Township of Melancthon
157101 Highway 10
R.R. # 6
Shelburne, Ontario
L0N 1S9

**Re: 5th Sideroad Bridge Damage Caused by Truck
File No. MSO 15058**

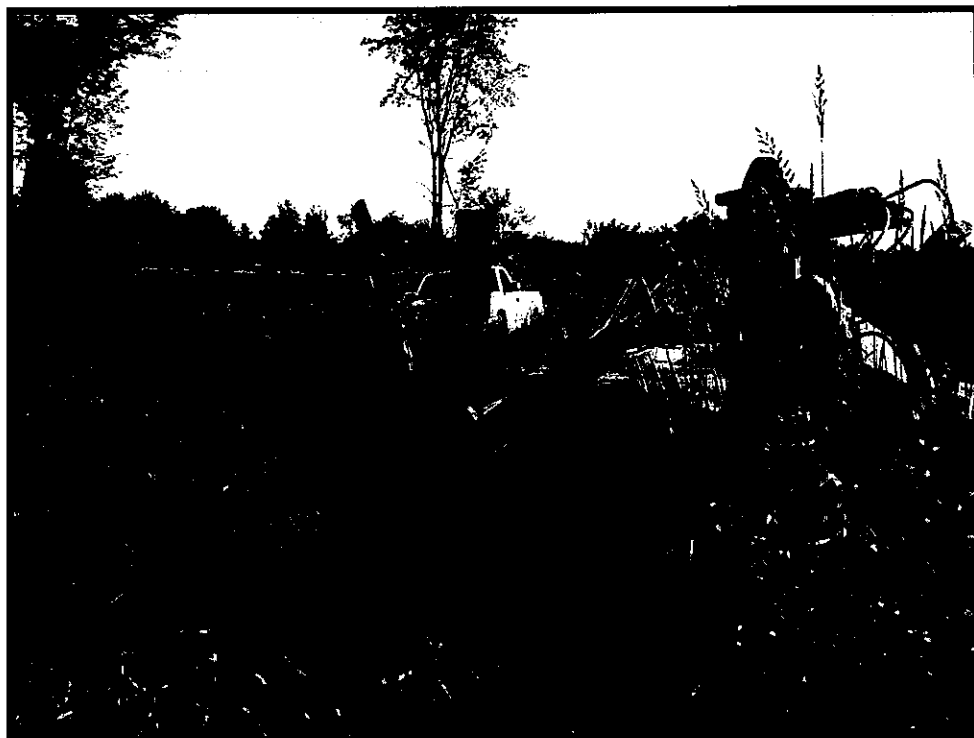
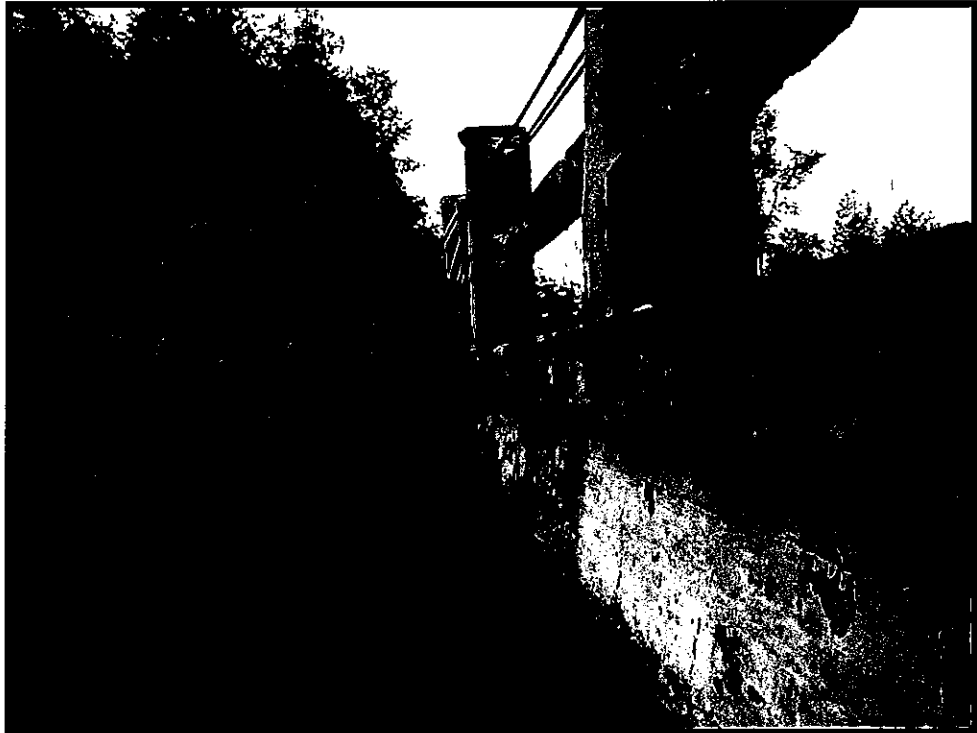
On Tuesday June 23rd, 2009 Helen Jenkins met with Alan Braydon on 5th Sideroad of Melancthon. The damages to the bridge caused by the truck were inspected and the relevant photographs are attached below. Although the structures concrete barriers have been severely damaged, the soffit remains in fairly good condition. Therefore, we have decided on the following solutions to create a safe alternative along with an approximate cost for each option:

<u>Option</u>	<u>Cost</u>
1) Replace with new concrete barriers up to code	\$35,000
2) Install temporary concrete barriers until replacement	\$7,500
3) Repair post and rail as is	\$15,000

It is our opinion that 'Option 2 – installing temporary concrete barriers' is the best decision at this time. The existing condition of the wingwalls of the bridge is too poor to allow barrier reconstruction. Installing temporary concrete barriers is recommended until the bridge can be replaced. Repairing the exiting concrete post and rail barriers as is would be expensive and would not be in accordance with current codes of practice.

In each of these cases the Township could consider the installation of approach guiderail in addition to the barriers; however this has not been included in the above cost estimates.

Given that the structure is due to be replaced, and that the road is not used during the winter months, The Township could also consider only removing the existing barrier and placing traffic control pylons and warning signs instead.
